Mobility Analysis Report

Fallbrook Village Sub-Area Plan

*Prepared for:
County of San Diego
Planning and Development Services*

June 8, 2023

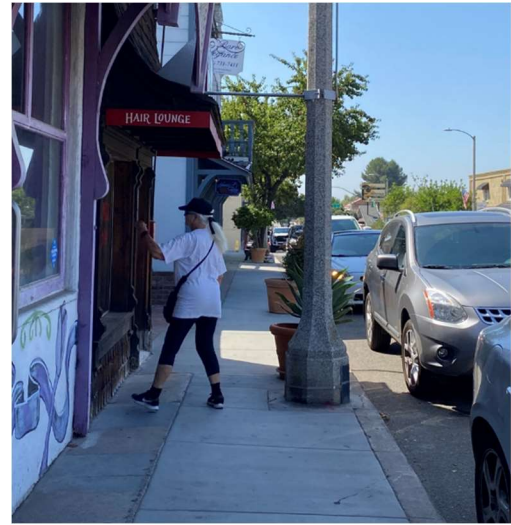
Figure 1: Existing sidewalk on Main Avenue show deficient widths between building and streetlight. (<4 feet)

While some parts of the corridor consist of 8-foot to 11-foot sidewalks, these are essentially formed by extensions of adjacent parking lots. In the southern area of Main Avenue, south of College Street, wide driveways reduce the availability of sidewalks and increase the exposure for pedestrian to circulating vehicles.

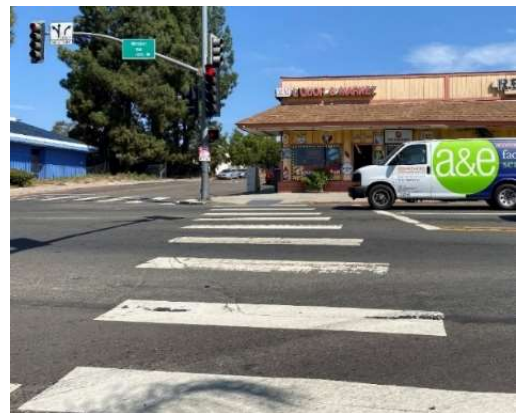
Figure 2: Existing crosswalk at Mission Road and Main Avenue show deteriorating pavement markings

Along Main Avenue, intersection controls consist of a combination of traffic signals and side-street stop controls. The traffic signals have controlled pedestrian crossing phases whereas the intersections with stop signs are uncontrolled pedestrian crossings. There are existing high-visibility continental crosswalks at locations like Aviation Road, Fallbrook Street, Elder Street, Fig Street, and Mission Road. High visibility crosswalks have extra paint to bring more awareness to drivers as well as increased visibility for the sight-impaired when compared to a “standard” crosswalk with a simple 12” line. Additional high-visibility crosswalks (i.e. continental crosswalks as shown in [Figure 4](#)), especially South of Elder Street and Fallbrook Street could be provided to increase pedestrian comfort while crossing Main Avenue. Throughout the corridor, there are different types of crosswalk designs including, stamped, continental, and striped. Many of the crosswalk pavement markings are beginning to fade and need to be restriped.

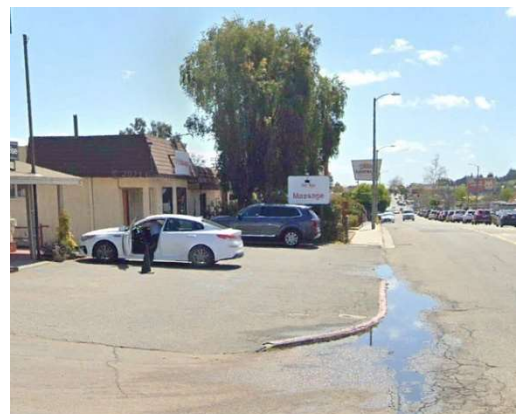
Figure 3: Parking lot extensions into sidewalk right of way

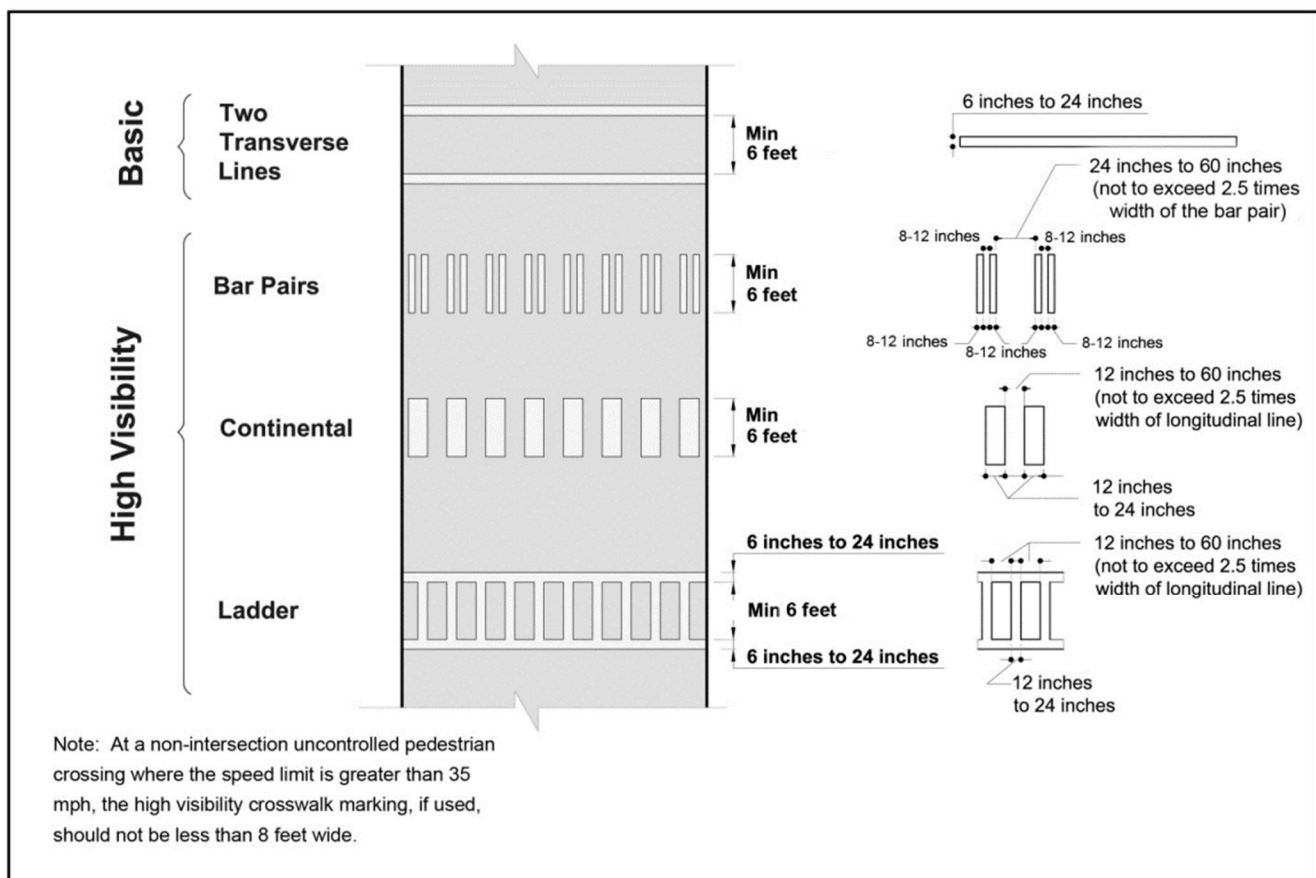
Figure 4: Crosswalk Pavement Marking Types

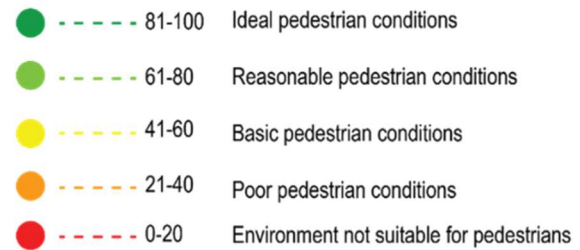
Figure 5: PEQI Score Range

The total PEQI score can range from 0 to 100 points, broken into the five categories shown in **Figure 5**.

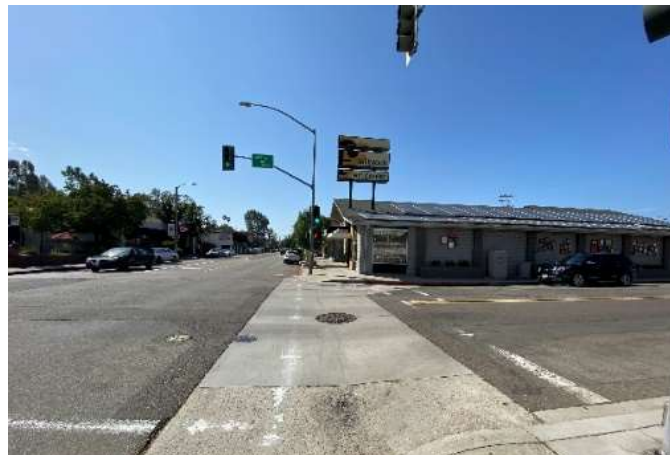
Figure 6: Example of an intersection (Main Ave at Alvarado St) that may

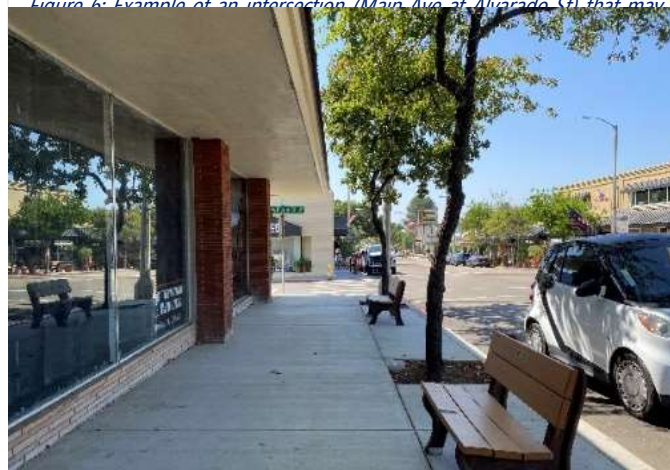
Figure 7: Example sidewalk along a roadway segment (east side of Main Ave north of Hawthorne St) with “reasonable pedestrian condition”

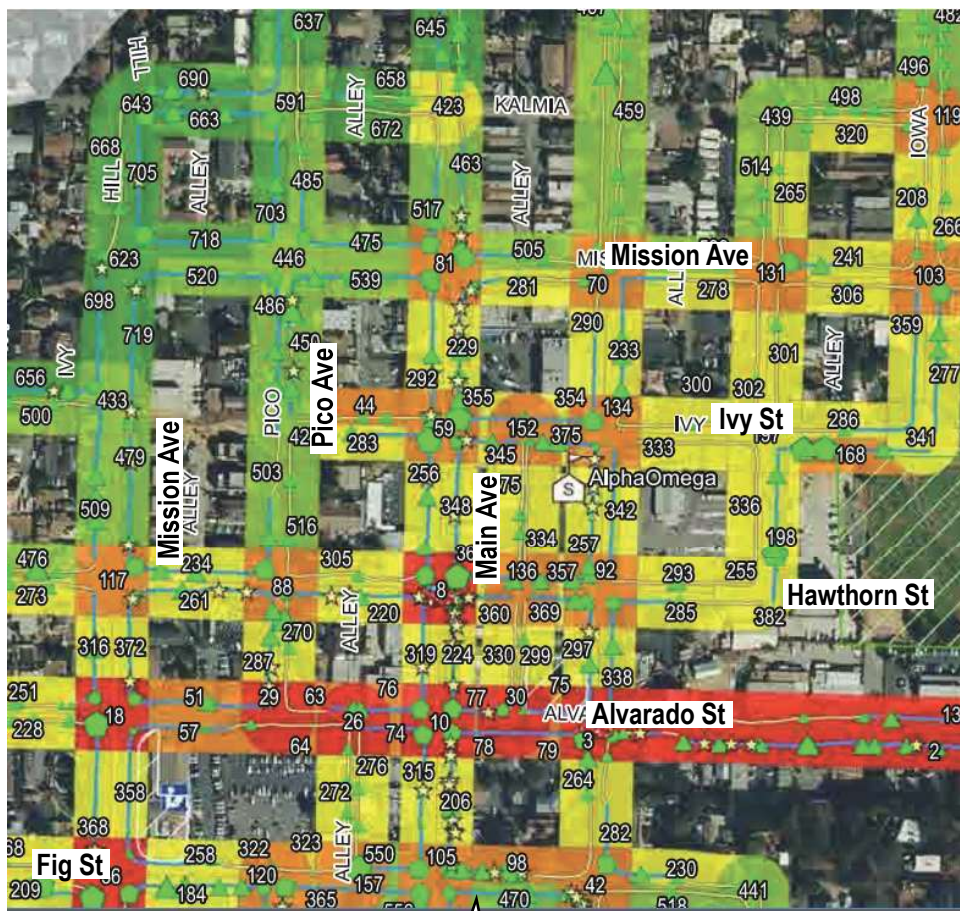
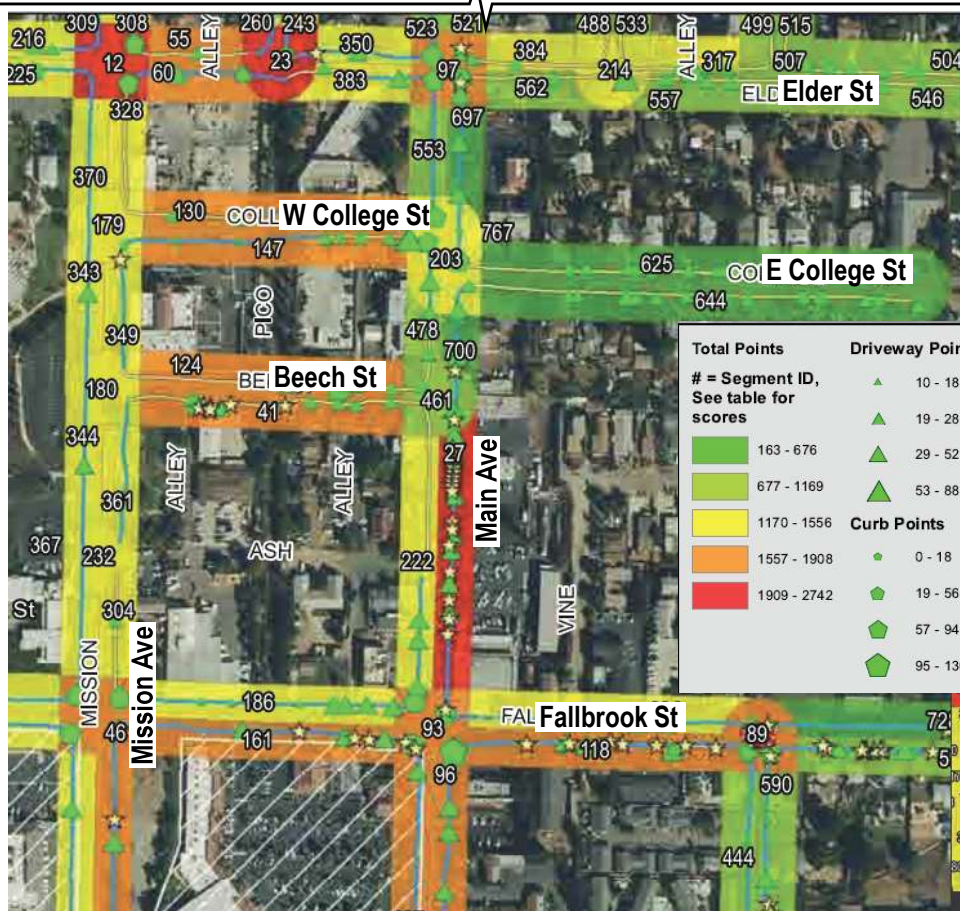
pedestrian facility and a lack of pedestrian accessibility. When an existing pedestrian facility is ranked as “poor” and “very poor”, the facility should be further evaluated to address the gaps. The main priority of the PGA system is to prioritize the need for pedestrian improvements.

In comparison, the PEQI is a qualitative pedestrian survey of the street that assesses the overall quality of the walking environment along roadway segments and at intersections. When the PEQI score for a roadway segment or intersection results in “not suitable for pedestrians”, the PGA rank typically aligns with a ranking of “poor” or “very poor”.

Total Points	Driveway Points	Point of Interest
# = Segment ID, See table for scores	▲ 10 - 18	— Sidewalk
163 - 676	▲ 19 - 28	— No Sidewalk
677 - 1169	▲ 29 - 52	🚗 Ped Related Collision
1170 - 1556	▲ 53 - 88	📖 Library
1557 - 1908	● 0 - 18	🏫 School
1909 - 2742	● 19 - 56	🏠 Attractor Land Use
	● 57 - 94	🌳 Parks
	● 95 - 130

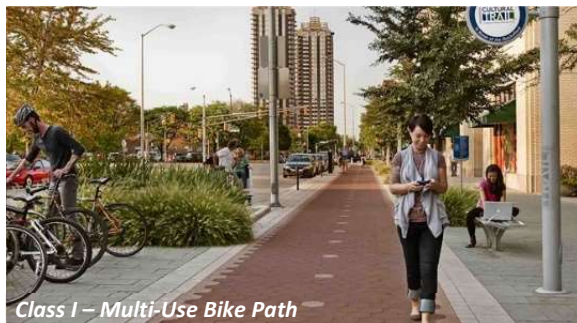
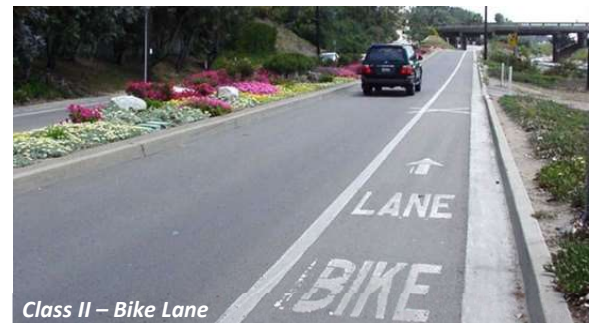
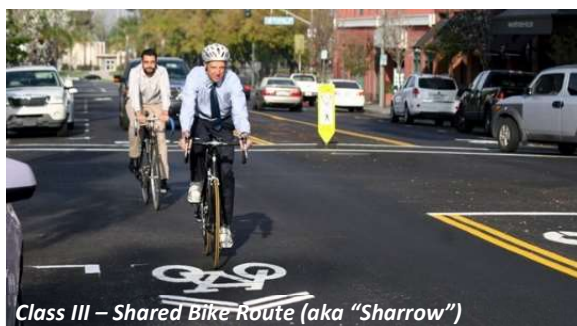
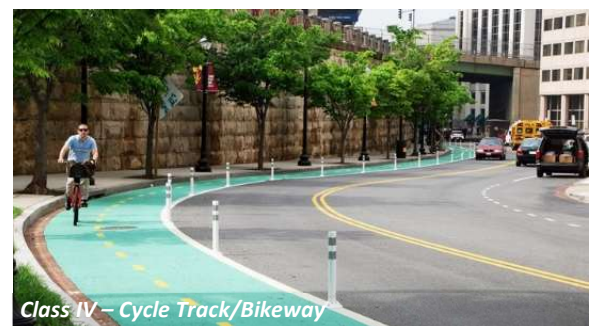
- **Class I – Multi-Use Bike Path:** Bike paths provide a completely separate off-road right of way for exclusive use of people walking and biking.
- **Class II – Bike Lane:** Bike lanes are defined by pavement striping and signage and effectively dedicate a portion of the roadway right-of-way for exclusive bicycle travel.
- **Class III – Shared Bike Route (aka “Sharrow”):** Bike routes are a shared use with vehicular traffic within a travel lane and used in conjunction with pavement striping and signage.
- **Class IV – Cycle Track:** Protected bike lanes (bikeway) provide space adjacent to the roadway that is exclusively for bicyclists and physically separated from vehicular travel lanes, parking and sidewalks.

Figure 8: Bicycle Facility Classifications

Classification of bikeway facilities fall into one of the following categories as shown in **Figure 8**:

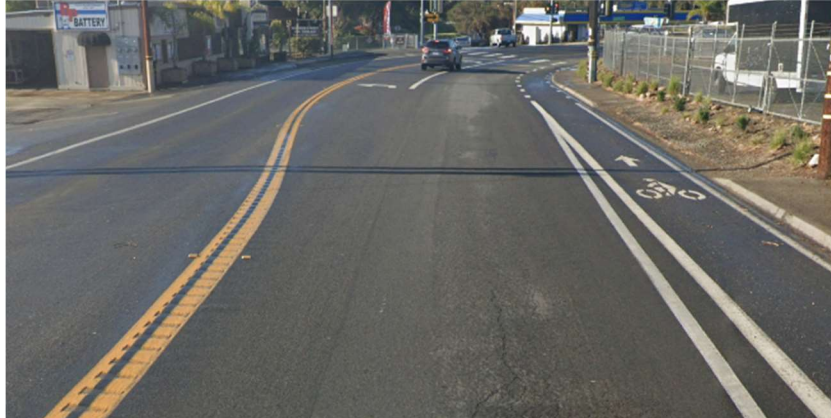
Figure 9: Existing Class II bike lane on East Mission Road east of Brandon Road

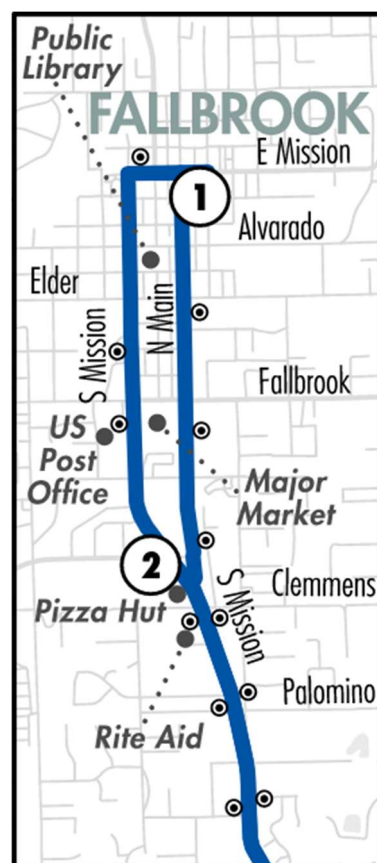
Figure 10: NCTD Route 306

North County Transit District (NCTD) operates the local bus service within the Fallbrook Community. NCTD's BREEZE Route 306 travels along Mission Road and loops back down Main Avenue as shown in **Figure 10** connecting Fallbrook, Bonsall, and Vista. The route travels to and from the Vista Transit Center which provides local connections to seven other BREEZE routes as well as the SPRINTER light rail line.

Within the Fallbrook Village Sub-Area, there are 10 bus stops along Mission Road and Main Avenue. The existing quality for each bus stop was evaluated based on the presence of the following amenities which are summarized in **Table 8** and **Exhibit 9**:

Note: Bus Stop locations are illustrated in **Figure 10** and illustrated northbound, counterclockwise

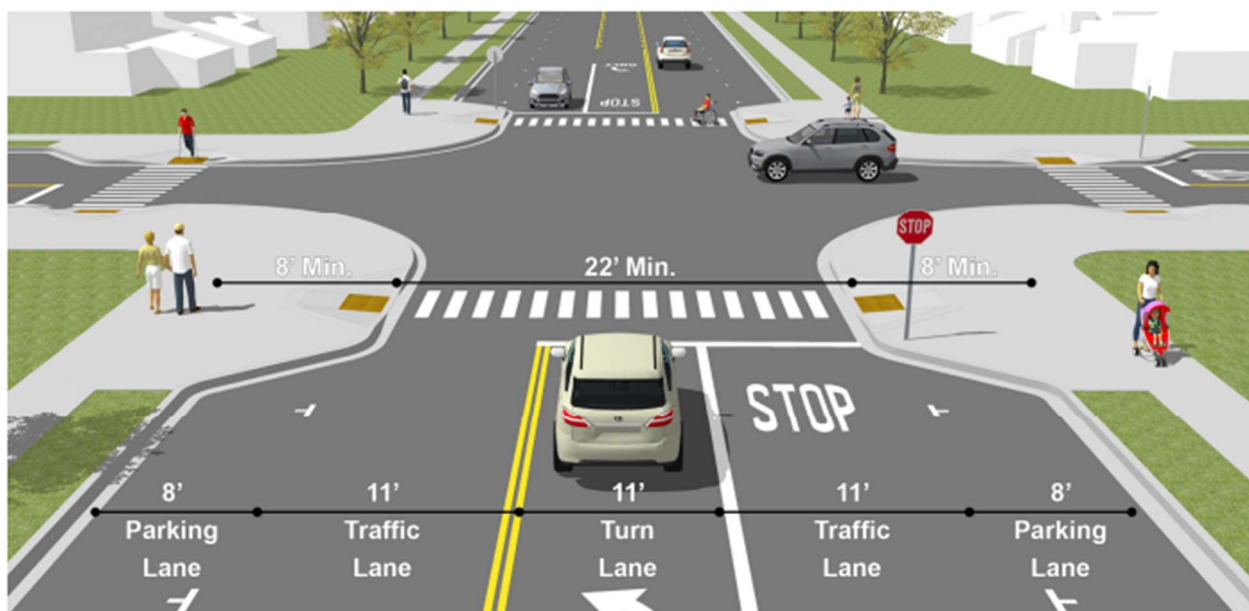
Figure 11: Typical Cross Section with Curb Extensions (Source: SDC ATP: Appendix B – ATP Toolbox)

Curb extensions increase visibility for pedestrians and drivers by bringing the pedestrian closer to the edge of the travel-way at a marked crossing. This reduces the pedestrian crossing distance which reduces the time pedestrians are in the street. Curb extensions also provide visual friction which can result in more cautious driving and can result in slower vehicle speeds.

Road classification, lane width, road width, sidewalks, curb radii, truck turning radii and on-street parking should all be considered when designing curb extensions. Appropriate signage for vehicles, bicyclists, and pedestrians should be provided at all potential conflict points. Placement of street furniture and landscaping on curb extensions should ensure that sight lines are not obstructed and properly maintained.

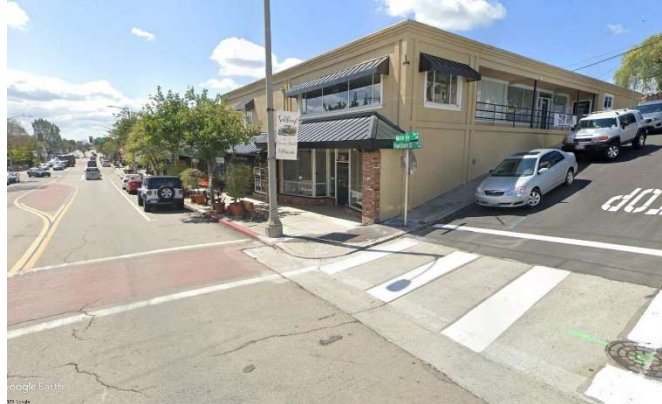
Figure 12: High Visibility Continental Crosswalk and Basic Crosswalk with Decorative Paving at Main Avenue and Hawthorn Street

The *California Manual on Traffic Control Devices (CA MUTCD)* identifies three types of crosswalks as appropriate for marked pedestrian crossings: ladder, diagonal, and continental (see [Figure 4](#)). Diagonal and continental are considered high visibility crosswalk markings per the *CA MUTCD*. To improve the visibility of the existing marked crossings and for all new marked crossing installations, continental crosswalks are preferred over standard parallel crosswalks.

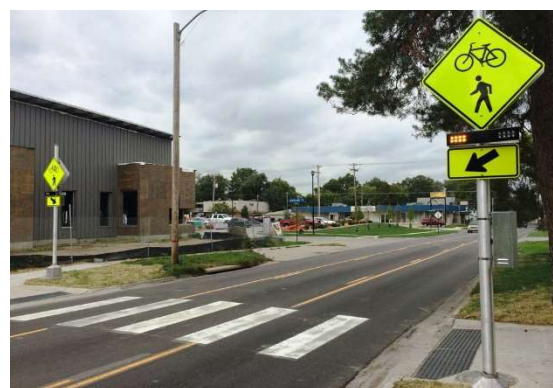
Figure 13: Activated RRFB on two-lane roadway (City of Lincoln, NE)

Rectangular Rapid Flashing Beacons (RRFB's) are pedestrian activated enhancements used to improved visibility and increase driver awareness at uncontrolled marked crossings. The device includes two rectangular shaped yellow indications with LED light's that flash when activated by either a pedestrian, or passively through detection. RRFB's may be powered by a standalone solar panel unit, or hard-wired to a nearby power source.

RRFB's improve pedestrian safety and increase motorist yielding at crosswalks at a lower cost compared to pedestrian signals.

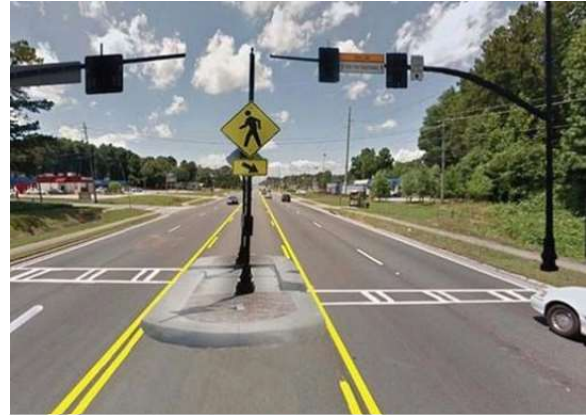
Figure 14: Example of pedestrian signal

Controlled Pedestrian Crossings, such as a High-Intensity Activated Crosswalk (HAWK) Signal, or a Pedestrian Signal, are used to warn and control vehicle traffic at a marked crosswalk. Controlled Pedestrian Crossings are typically located mid-block or at an intersection where a traffic signal is not warranted for vehicular traffic. Unlike RRFB's, controlled crossings provide a clear indication for the assignment of right of way at the marked crosswalk and vehicles are required to stop at these controlled crossings when activated by a pedestrian.

Both the driver and the pedestrian or bike are provided a clear indication of when to stop or wait and when to proceed. The signal or HAWK is activated by the pedestrian using a push-button and pedestrians must wait for the WALK sign to proceed. During that time, autos are provided a RED light and are required to stop. If the signal is not activated by a pedestrian, motorists are permitted to drive through the crosswalk but are cautioned to slow down and look for the presence of nearby pedestrians.

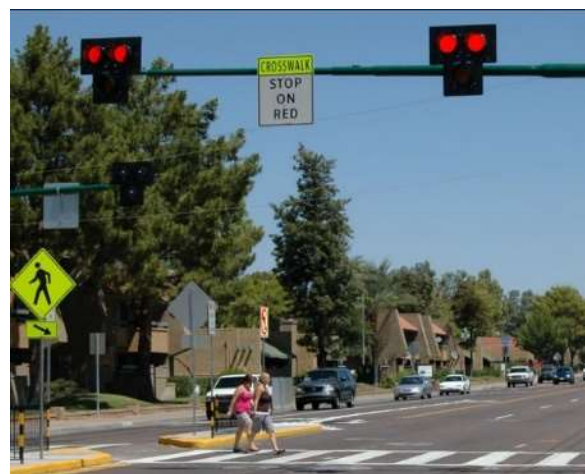
Figure 15: Example of HAWK signal at controlled crosswalk.

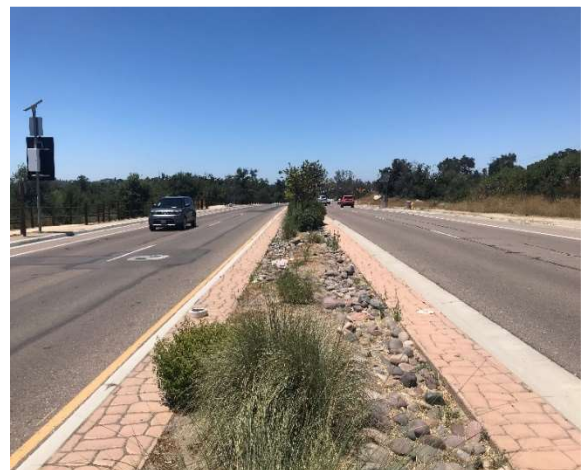
Figure 16: Example of a raised median

Continuous raised medians may restrict vehicular access at intersections and driveways. They may be used to concentrate left-turn movements at specific locations and tend to result in an increase of the frequency of U-turns at a signalized intersection or at gaps in the median. However, raised medians can improve safety by providing a physical barrier between opposing directions of traffic thus reducing vehicle conflicts.

Raised medians tend to serve as a place of refuge for pedestrians and bicyclists who cross a street midblock or at intersections. In addition, raised medians allow pedestrians and bicyclists to cross one direction of traffic at a time. In addition, medians with natural landscaping also serve as natural bio-swaes for managing stormwater. While medians are a viable streetscape treatment, they may not be feasible or desirable in the Town Center area.
